SERVICE BULLETIN Title: XT Series Battery Protection / Mast Cam Handle Wire

Identification	SB-006
Status	Active
Issue	1
Issue Date	17 April 2007
Applicability	XT 912, serial numbers 001 to 0169 inclusive XT 582, serial numbers 001 to 0040 inclusive unless previously accomplished.
Compliance	Optional

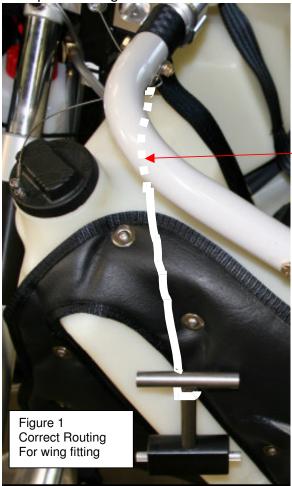
Cable UNDER seat frame

- 1. The cable is routed underneath the seat frame.
- 2. The handle is placed outside of the aircraft.

as depicted in Figure 1.

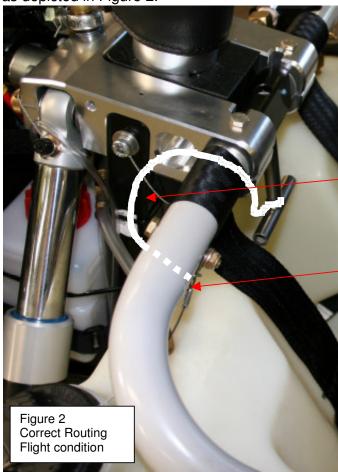
Cable around the back of and OVER seat frame

Cable UNDER seat frame

- 1. The cable is routed underneath and around the rear of the seat frame.
- 2. The handle is placed in the slots.
- 3. The handle is rotated downwards into the locked position.

as depicted in Figure 2.

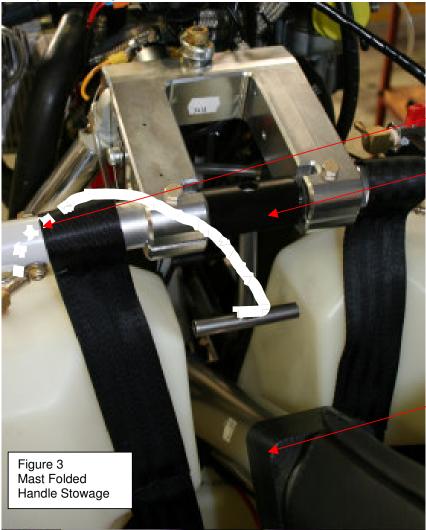
Mast Folded for transport

Cable UNDER seat frame, then around the rear of the seat frame.

Handle stowed in the mast cam handle slots

- 1. The cable is routed underneath and around the rear of the seat frame.
- 2. The handle is placed in the slots to hang.

as depicted in Figure 3.
