SERVICE BULLETIN

Title: Control Frame Top Security

Identification	SB-021
Status	Recommended
Issue	1
Issue Date	11 December 2018
Applicability	All Airborne Wings
Compliance	Prior to next flight and incorporated in pre-flight inspection.

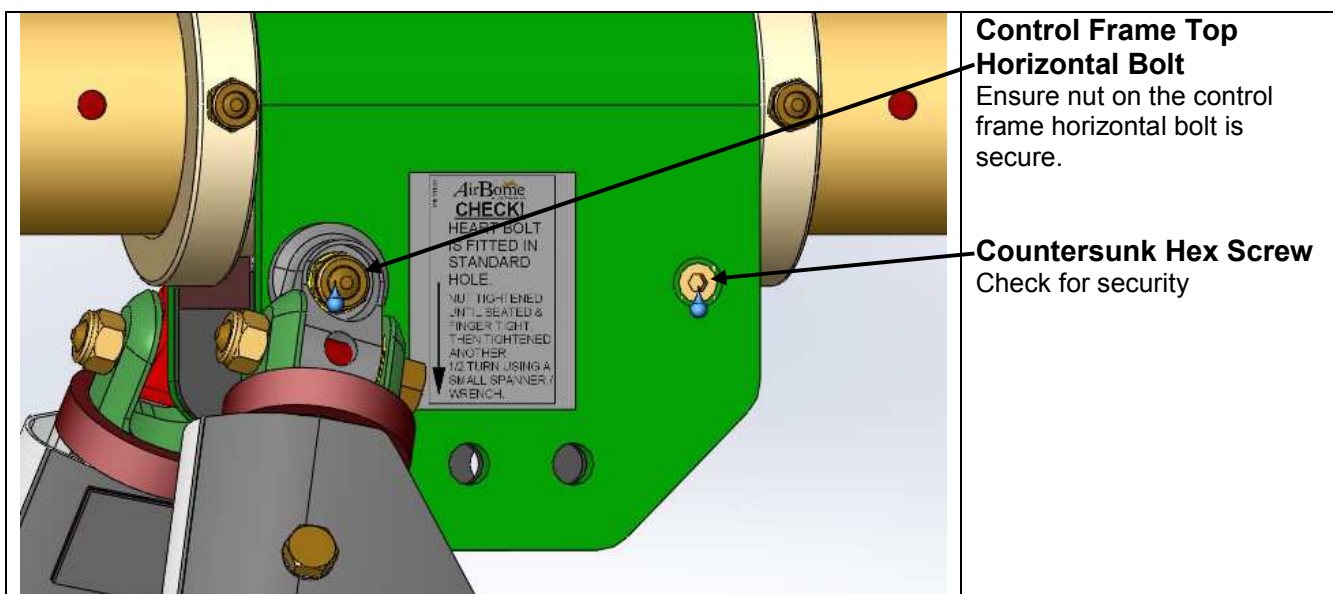
Airborne Windsports has received reports of loosening of the AN5 nut of the control frame top horizontal bolt. The bolt and nut secure the down tube top knuckles to the U Bracket. In one reported case the nut was completely removed from the bolt. Another reported that the nut was out of the nyloc.

When the nut is checked for security the counter sunk hex screw should also be checked

Tension as per Wing Maintenance Manual. If the nut is loose it should be replaced with a new one. Loctite 262 should be used on the thread in addition to a new nut.

If the countersunk hex screw is loose it should be removed (one side at a time). Loctite 212 should be applied to the thread and then tensioned.
