SERVICE BULLETIN

Title: Oil Radiator Fitment XT 912

Identification	SB-023
Status	Advisory
Issue	1
Issue Date	15 September 2020
Applicability	All XT 912
Compliance	When replacing Oil Radiator

Issued by: Rick Duncan
Approved by: Rick Duncan – Airborne Windsports.

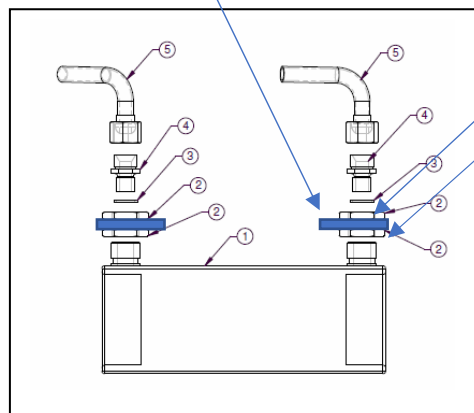
Older model radiators had two oil cooler nuts (Item 2 - Airborne Part # 105654) positioned either side of the attachment point of the engine mount.

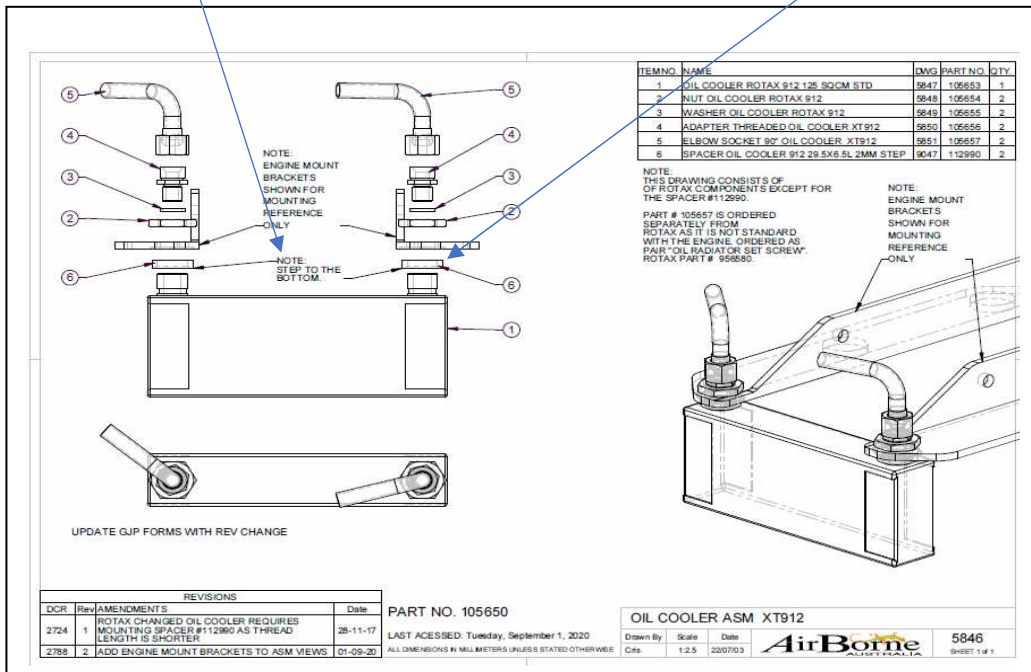
Incorrect fitment has caused tension on the radiator flange. The tension load combined with vibration has caused the flange to shear from the main radiator body.

2017 versions and after require Spacer (Item 6 - Airborne Part #112990) and only one nut.
 Note orientation of spacer

The new version radiator must have spacer (Airborne part #112990) fitted between the radiator and the engine mount. Failure to do so will put undue stress on the radiator causing failure at the flange attachment point.
