SERVICE BULLETIN

Title: Helmets - Microlight - Type: Icaro

Identification	SB-012
Status	Active
Issue	1
Issue Date	27 September 2011 Revised 6 th February 2011
Applicability	Icaro microlight helmet
Compliance	Mandatory

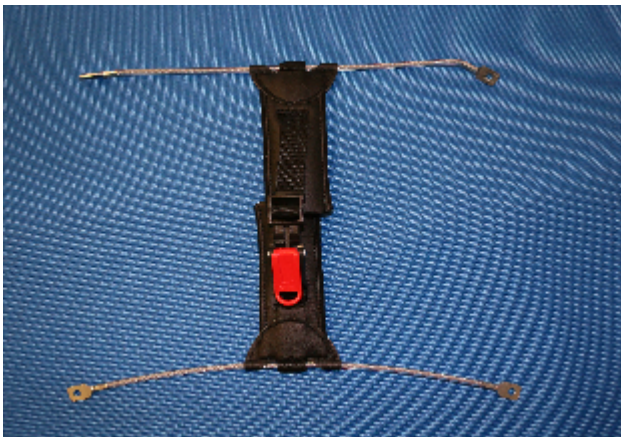
It has been brought to our attention that the wire loops that hold the chin straps on Icaro Microlight helmets can fail. The failure point has been close to where the wire attaches to the helmet. It can start with a broken strand in the stainless steel wire.

This photo shows the old plastic coated wire loop

The plastic coated wire loops that were found to be faulty were used in a busy commercial operation. We recommend replacement and in the very least a regular pre flight of your equipment.

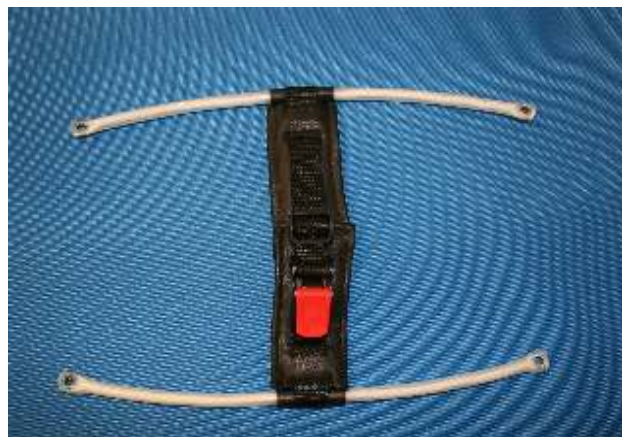
This photo shows the new plastic coated rope loop

UPDATE: Icaro have supplied thicker replacement rope loops with chin straps and screws to attach them. To get replacement the replacement: Contact spares@airborne.com.au or call +61 (0)2 49 449 199 and ask for spares.
